Spurious Emissions

The Newsletter of the South Bay Amateur Radio Society

Volume 5 Number 2

Spring 2016

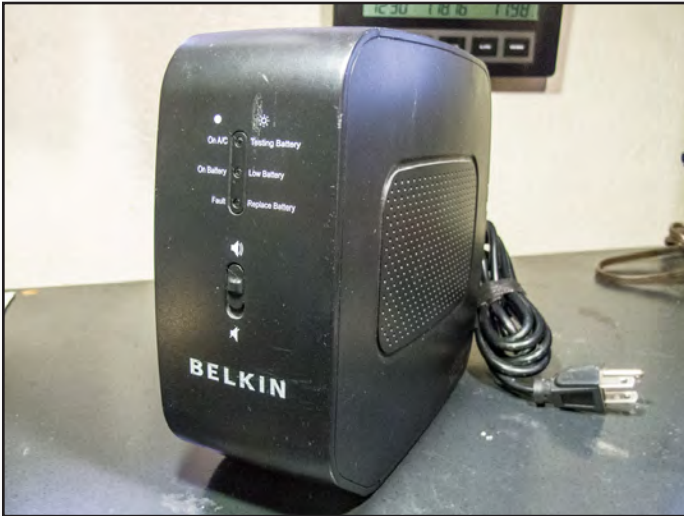
Figure 1. Belkin Residential Gateway Battery backup, front view.

Each unit contains a 7.5AH 12V sealed lead acid battery with associated circuitry to charge the battery from a normal household supply and furnish 12V output to the connected device. As configured, these devices are suitable for powering a cable modem/router in the event of a power failure. (FIGURES 1 & 2)

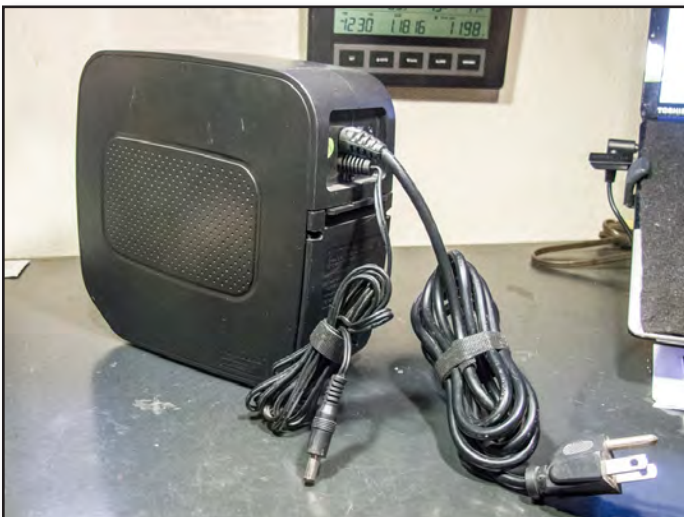
Figure 2. Belkin Residential Gateway Battery backup, rear view.

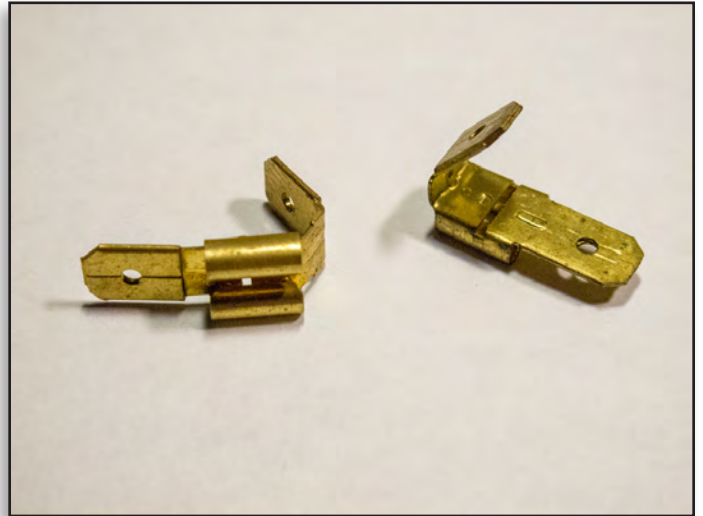
Figure 3: Double-tab spade connector.

With this in mind, I had to come up with a way to connect directly to the internal battery, but maintain the connections to the charging circuitry. This was accomplished by using a double-tab spade connector that slid directly onto the battery terminals, but allowed connecting two separate leads to the battery. (FIGURE 3) Because of the tight space within the housing and the fact that the leads attached to the battery in different directions, it was necessary to bend the spade connectors flat when attaching them to the battery. (FIGURE 4)

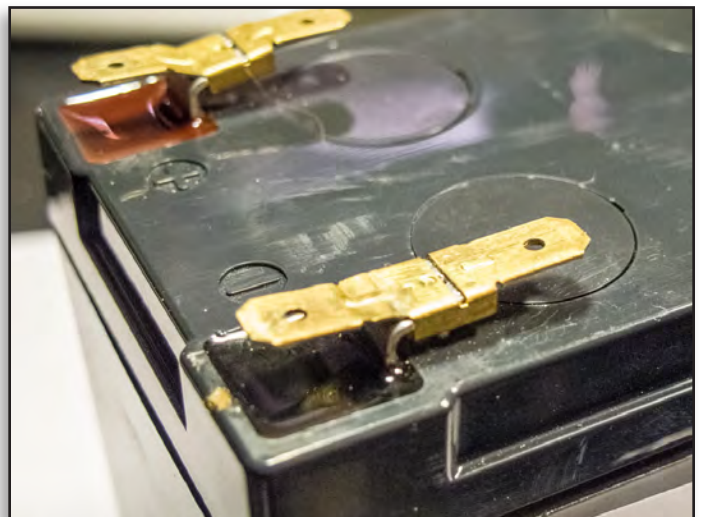
Figure 4: Double-tab spade connectors flattened and installed on battery.

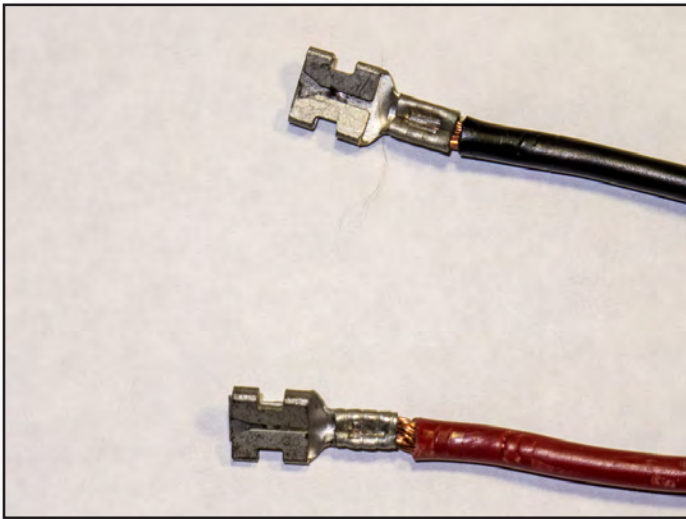
Figure 5: Spade connectors on one end of the harness.

The new harness consisted of black and red wires (length optional) with appropriate spade connectors on one end

and Anderson Powerpoles on the other. Powerpoles are the de facto ARES and ACS (RACES) method of connecting DC power and using them in this application allows a great amount of flexibility. (FIGURES 5 & 6)

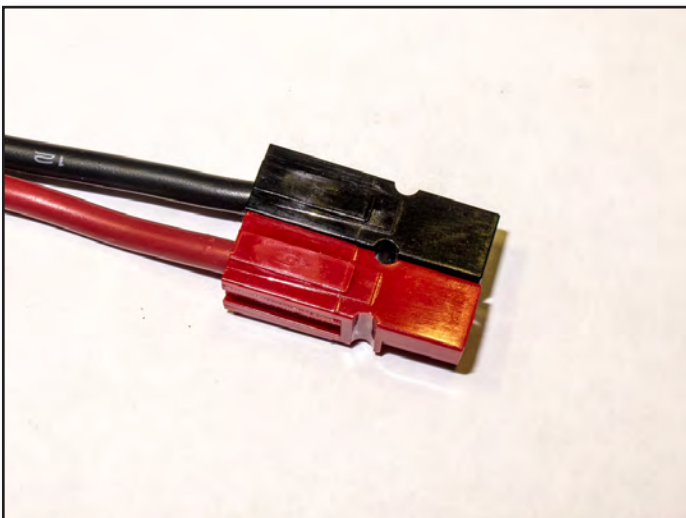
Figure 6: Anderson Powerpoles on the other end of the harness.

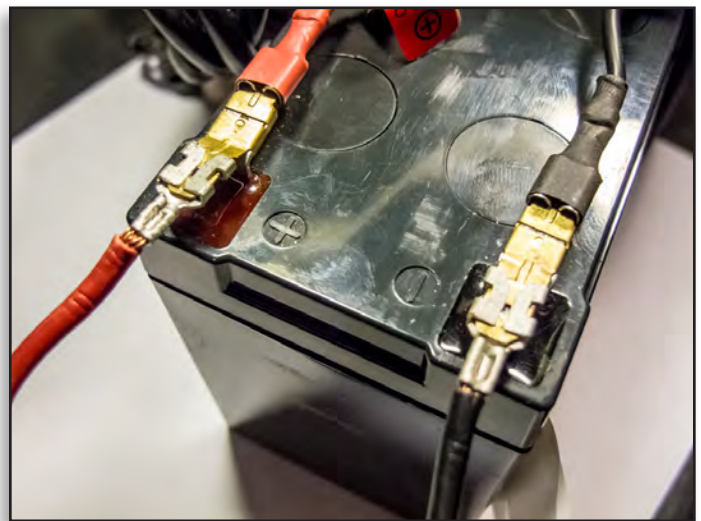
Figure 7: Harness connections made to battery.

All of the connections were made to the battery as shown (FIGURES 7 & 8) and the battery was slid back into the case. The new harness had to have some way to exit the case, so I used a small round file and carefully made two notches, one on each side of the cover for the wires to exit. (FIGURE 9)

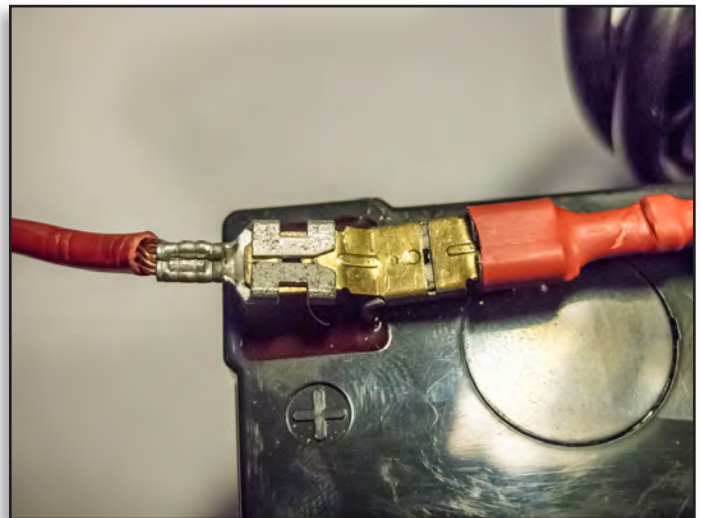
Figure 8: Close-up of connections made to the battery. Output harness to left; charging circuit to right.

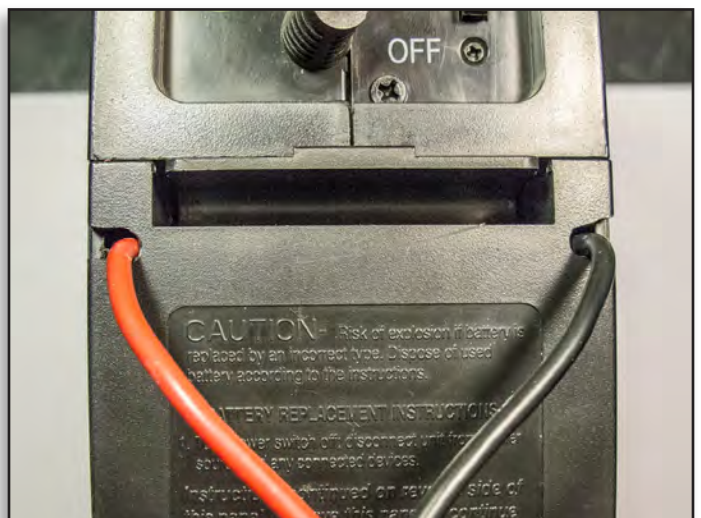
Figure 9: Harness wires exiting the case

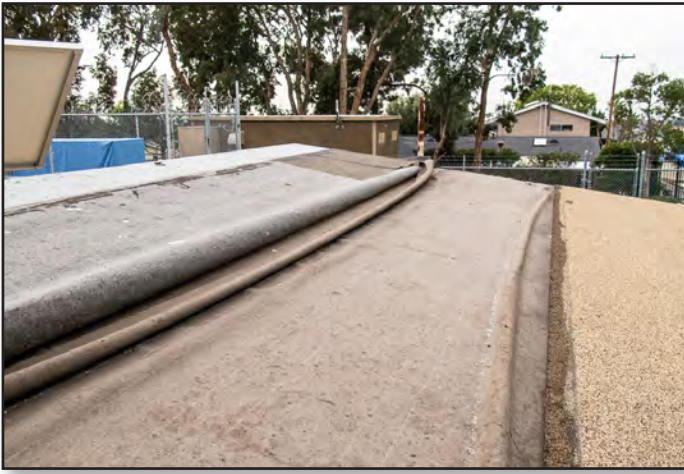
Roof shingling rolled up by the wind. *John Wright, K6CPO*

After the first major storm in January, Fred Curtis, KI6GRO, discovered that the wind had blown water into the building through the vents and the batteries were soaking wet. He also discovered that part of the shingling on the building roof had been pulled up by the wind.

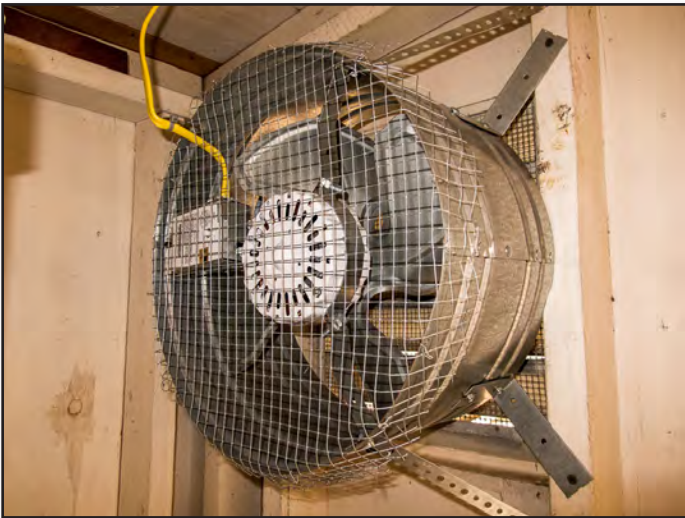
1000 CFM attic fan installed on building vent. *John Wright, K6CPO*

First was completing the installation of the attic fan purchased to increase airflow through the building during the hotter months of the year. We had not activated the fan as it vibrated excessively and the back needed to be covered for safety reasons. We installed additional reinforcing straps and a wire mesh cover on the back of the fan.

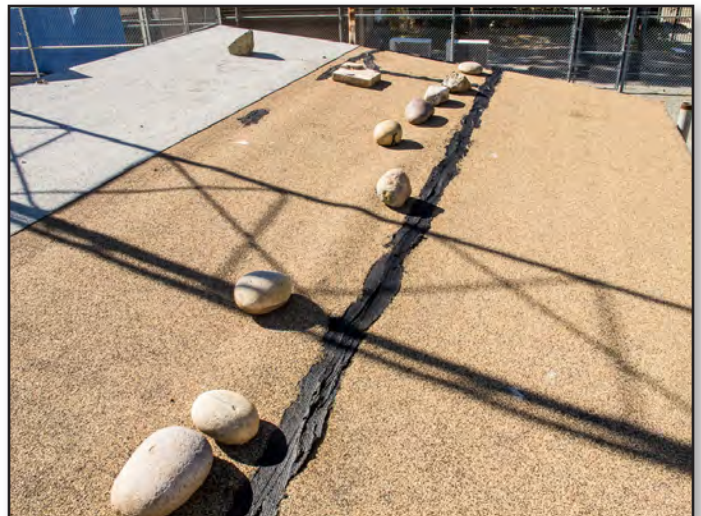
Temporary repairs to the building roof after the first storm. *John Wright, K6CPO*

When we did return, we found the city had made some repairs to the roof in the form of using roof patch to seal some of the torn places in the shingle. We added more patch of our own in addition to nailing down the edges of the shingles to prevent further lifting.

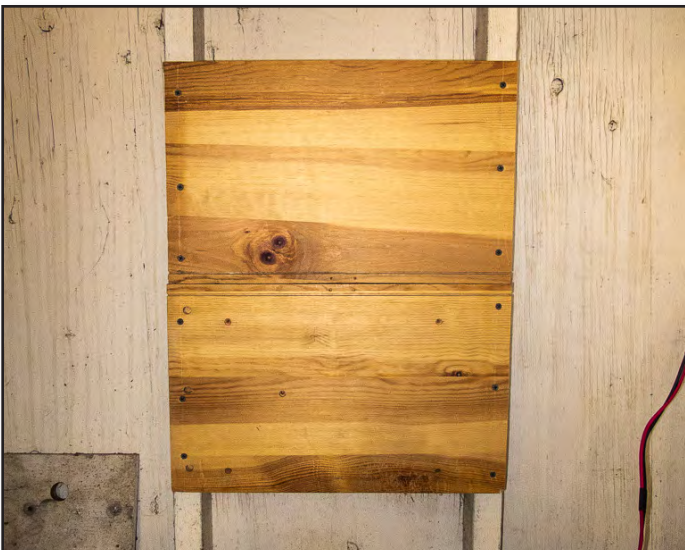
Boards installed in front of vent opening to prevent water intrusion. *John Wright, K6CPO*

To prevent further water intrusion through the vent closest to the batteries we installed a wood cover over the vent, but removed from it by the space of the wall studs. This way any water blown in would be diverted onto the floor and not on the batteries. At the same time we decided we should get all of our equipment up off the floor to prevent any additional water damage.

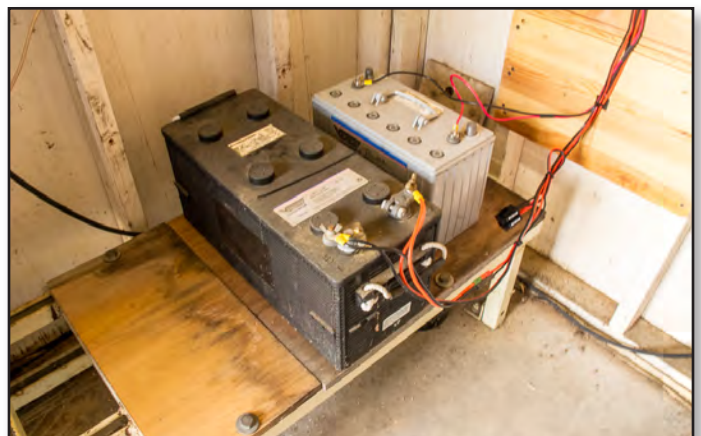
Repeater batteries moved off the floor. *John Wright, K6CPO*

During our previous visit, I had measured some existing bracketing in the building and cut some plywood shelves to fit the bracketing. We installed these and

moved the batteries up off the floor. This entailed some re-routing of the wiring, but this was accomplished without difficulty.

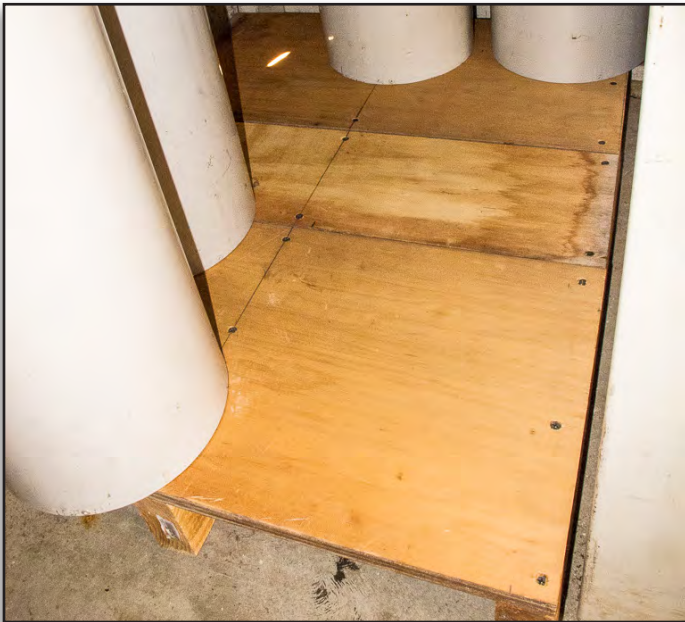
The platform to get the diplexer cans up off the floor.
John Wright, K6CPO

A couple of days later I went back to the site with a platform constructed of 2 x 4s and plywood and placed it behind the repeater cabinet. This raised the diplexer cans up off the floor and out of any potential water leakage.

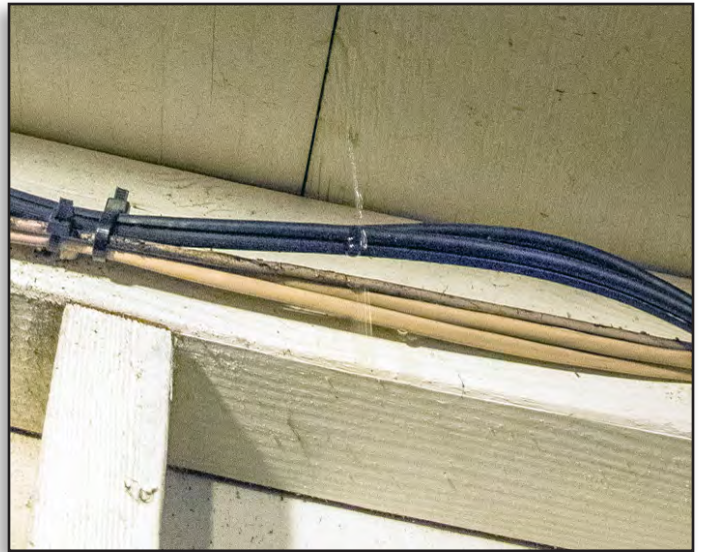
Water intrusion through a seam in the sheathing under the area where the shingles were torn off.

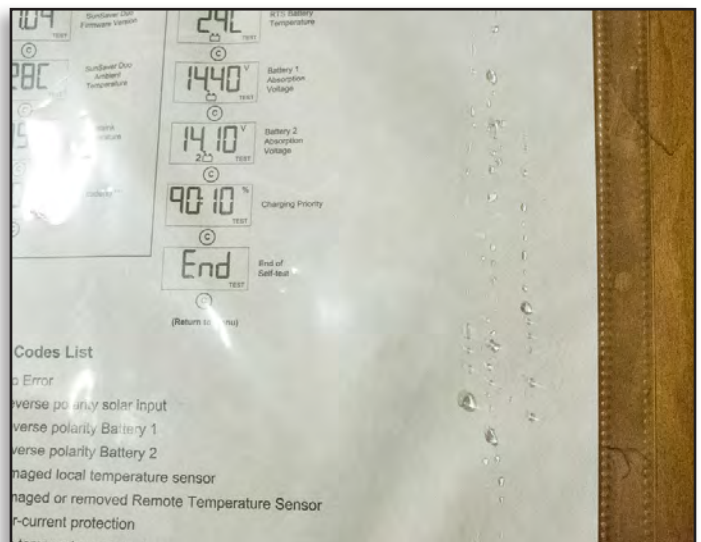
Water running down the posted instructions for the charge controller.

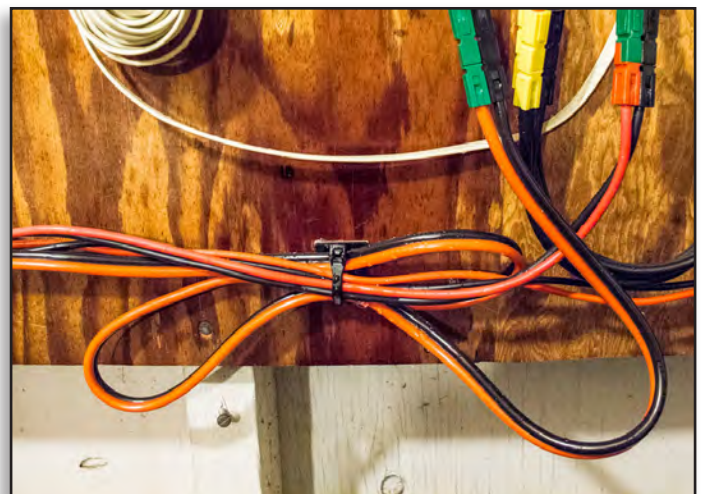
Water collecting on the solar charge wiring.

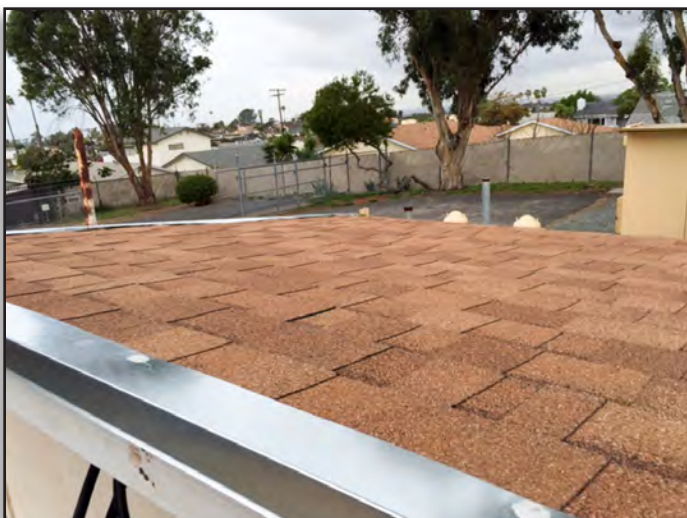
The contractor replaced some rotted wood around the edge of the roof, added a new layer of sheathing over the old, installed new drip edge, paper and shingles and added additional flashing on three sides.
Fred Curtis, KI6GRO

Again, the damage was reported to the City of Chula Vista. When, after a week had passed, we returned to the site with tools and some shingles to attempt a temporary repair to the roof. Much to our surprise and pleasure, we discovered repairs to the roof were already in process. While we were there, a private contractor hired by the city showed up to continue installing a new roof on the building.

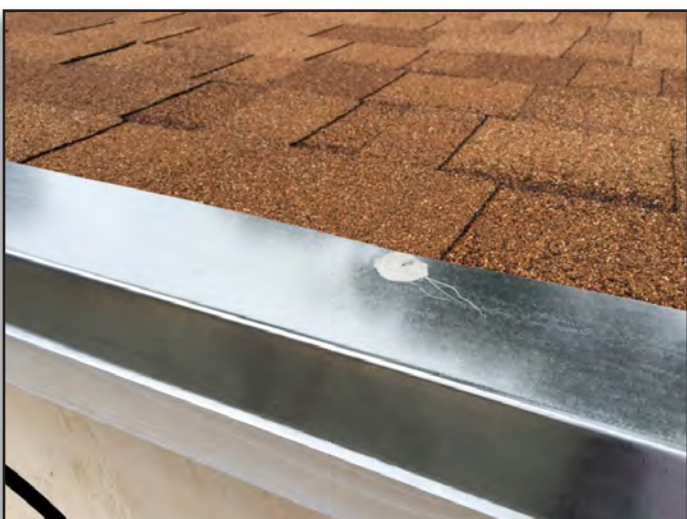
Close up view of the flashing over the high edge of the roof.
Fred Curtis, KI6GRO
